Inspector Report

National Home Inspections

Property Address:

873 S Main St.

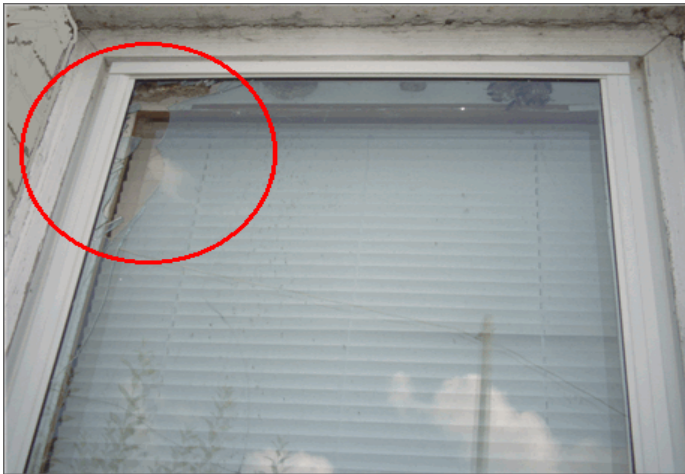
7) Window Observations There was a broken window at the North side of the home. Contact a general contractor for repair.

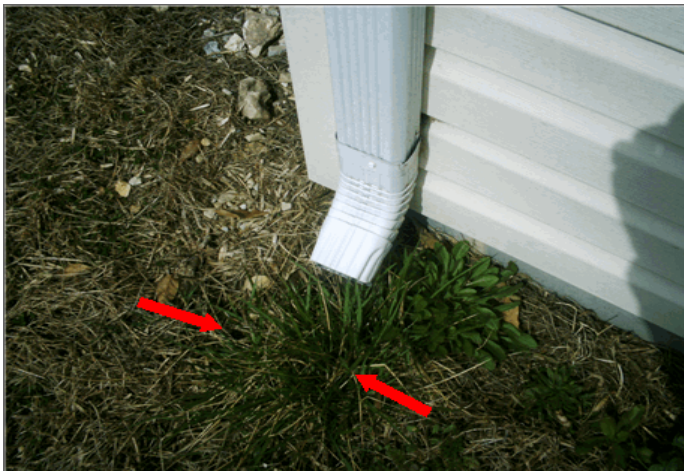
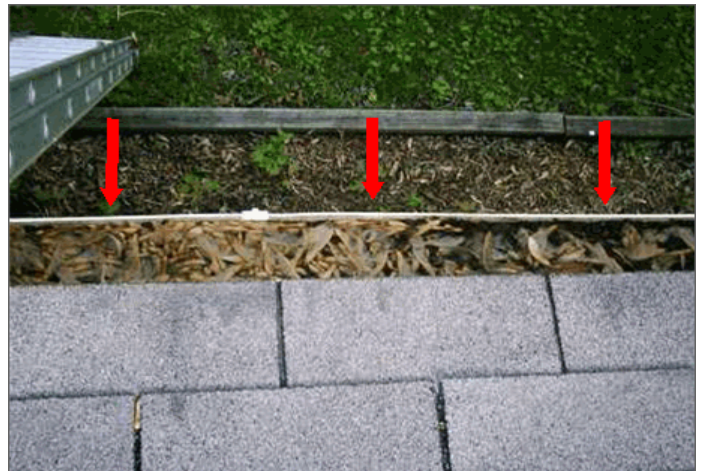
13) Gutter and Downspout Observations

Issue 1: The downspout on the South side of the home was missing a splash plate. The splash plate helps direct rainwater away from the foundation of the home. These can be purchased at your local hardware store and are relatively inexpensive to relapse. If you're not familiar with them contact a general contractor for repair.

Issue 2: The gutters were full of debris. It is recommended that the gutters be cleared of debris so that rainwater can flow properly. Contact a general contractor for repair.

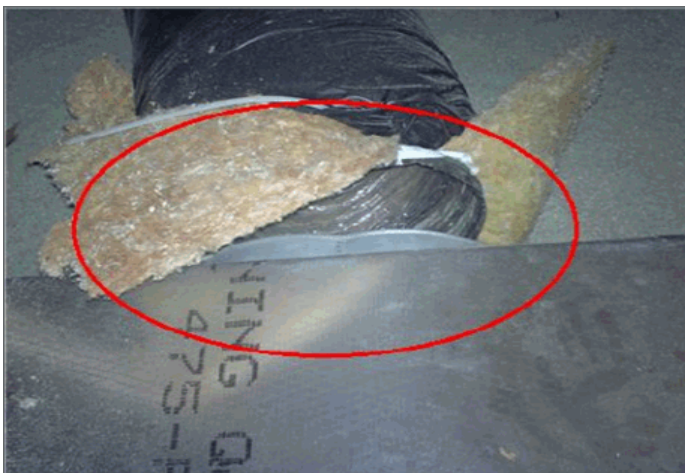
- 19) Distribution Observations
- Safety Issue:** The cool air return vent in the attic was disconnected from the furnace. This means that the furnace is sucking unfiltered air from the attic space and distributing it throughout the home. The insulation and dust may pose a health hazard. This condition will also significantly reduce the efficiency of the furnace. It is recommended that a certified HVAC contractor be contacted as soon as possible for repair.

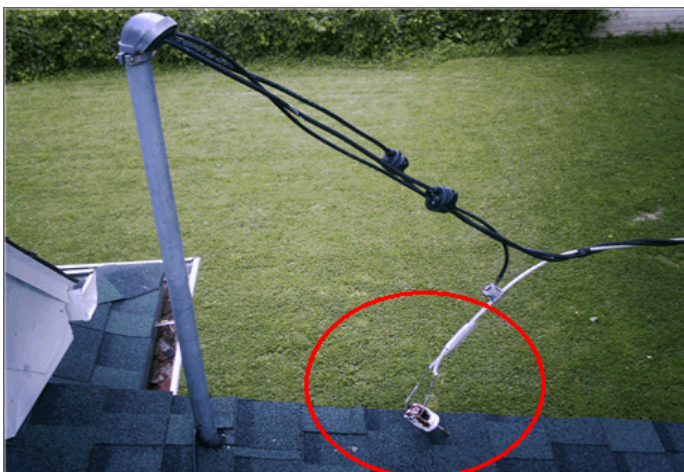
24) Electrical Service Observations **Safety Issue:** The anchor/insulator that supported the weight of the power lines had pulled loose from the home. If the wires come loose this can pose an electrical shock hazard. Contact a certified electrician as soon as possible for repair.

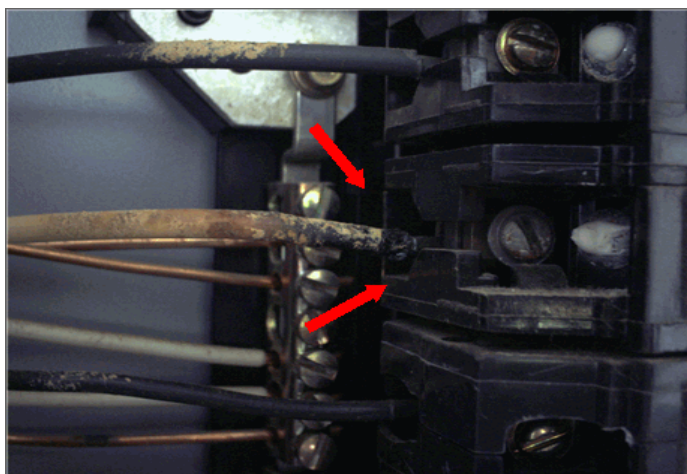
26) Electrical Panel Observations

Safety Issue: Scorched and melted wires were observed at the panel box. Recommend further evaluation and repairs by a licensed electrician prior to close.

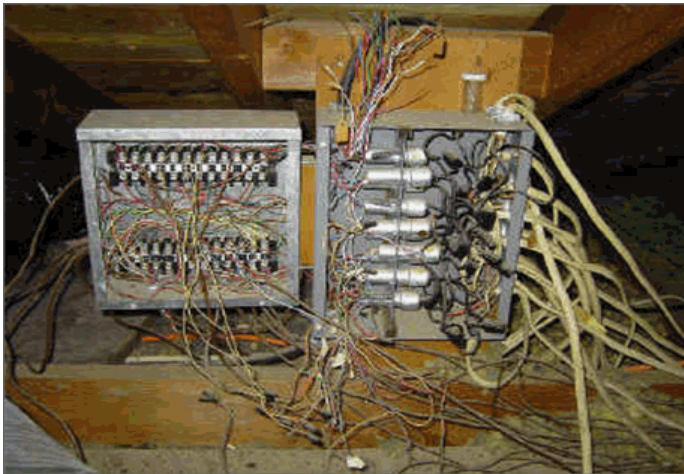
27) Subpanel Observations

Safety Issue: Loose wires were observed in the electrical panel. The electrical panel cover was missing which poses a shock hazard. This is a safety hazard and should be repaired as soon as possible. It is suggested that a "Licensed Electrical Contractor" be contacted for further evaluation and repair.

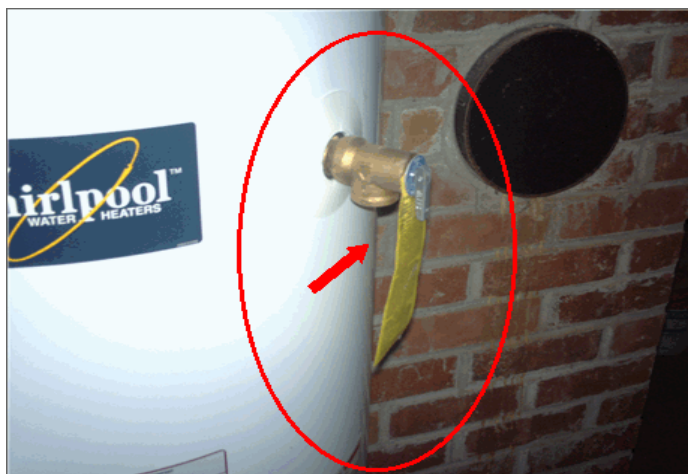
32) Water Heater Observations

Safety Issue: The TPR Valve was missing a discharge pipe that extends to within 6" of the floor. this may pose a safety hazard if the water heater were to discharge hot water. Contact a certified plumber for repair as soon as possible.

Plumbing	32	Safety Issue: The TPR Valve was missing a discharge pipe that extends to within 6" of the floor. this may pose a safety hazard if the water heater were to discharge hot water. Contact a certified plumber for repair as soon as possible.
Kitchen	58	The garbage disposal appeared to be leaking. Contact a certified plumber for repair.
Basement	80	Safety Issue: The basement stairs were missing handrails. This is considered a safety hazard. Contact a general contractor for repair.
Foundation - Crawl Space	102	Issue 1: There appeared to be termite damage on several of the floor joists in the basement. Contact a certified contractor for repair. Issue 2: There was evidence of active termites in the basement area. It is recommended that a termite inspection be performed. Contact a certified pest inspector for further evaluation and an estimate of damage.

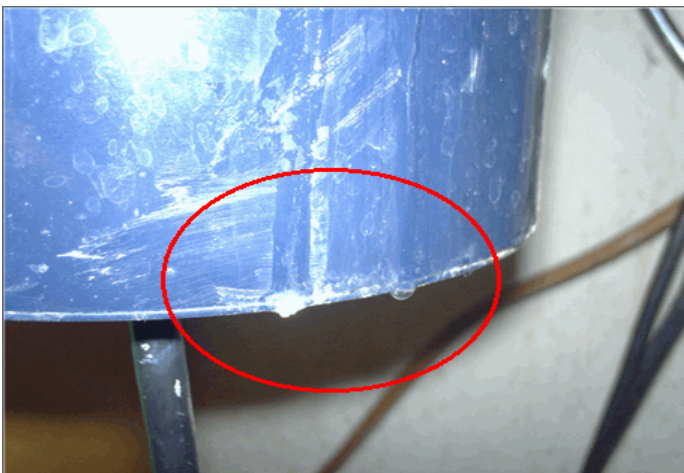
58) Garbage Disposal Observations The garbage disposal appeared to be leaking. Contact a certified plumber for repair.

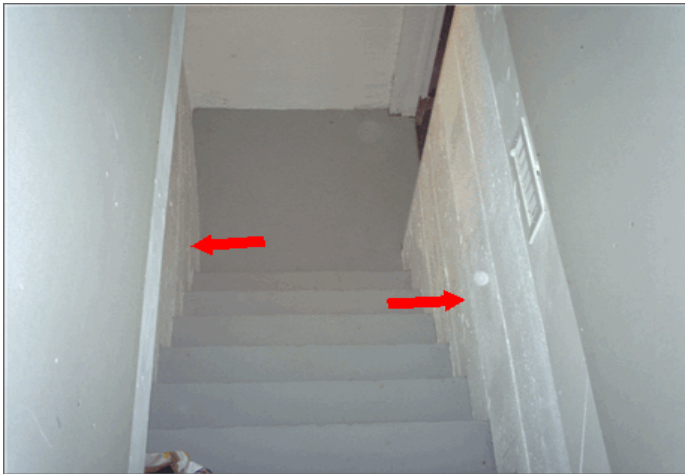
80) Basement Stair Observations **Safety Issue:** The basement stairs were missing handrails. This is considered a safety hazard. Contact a general contractor for repair.

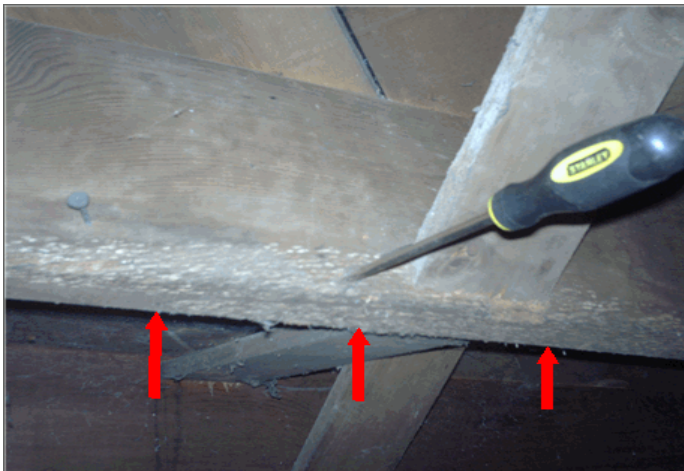
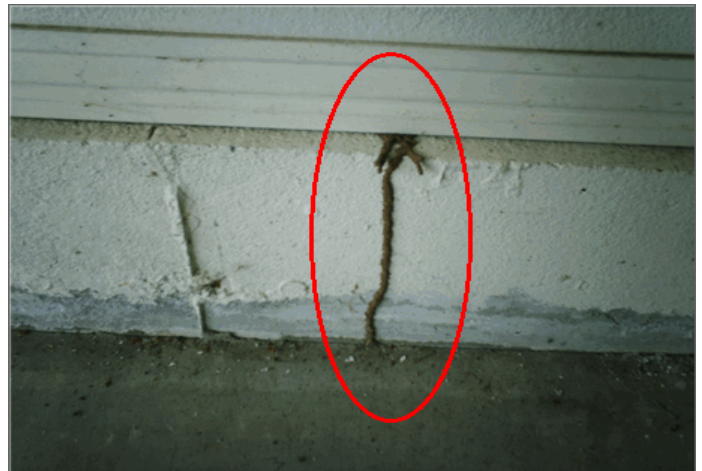
102) Flooring Support Observations

Issue 1: There appeared to be termite damage on several of the floor joists in the basement. Contact a certified contractor for repair.

Issue 2: There was evidence of active termites in the basement area. It is recommended that a termite inspection be performed. Contact a certified pest inspector for further evaluation and an estimate of damage.
